Tech Bulletin - Rockcrawler Side Guards - CJ, YJ and TJ*

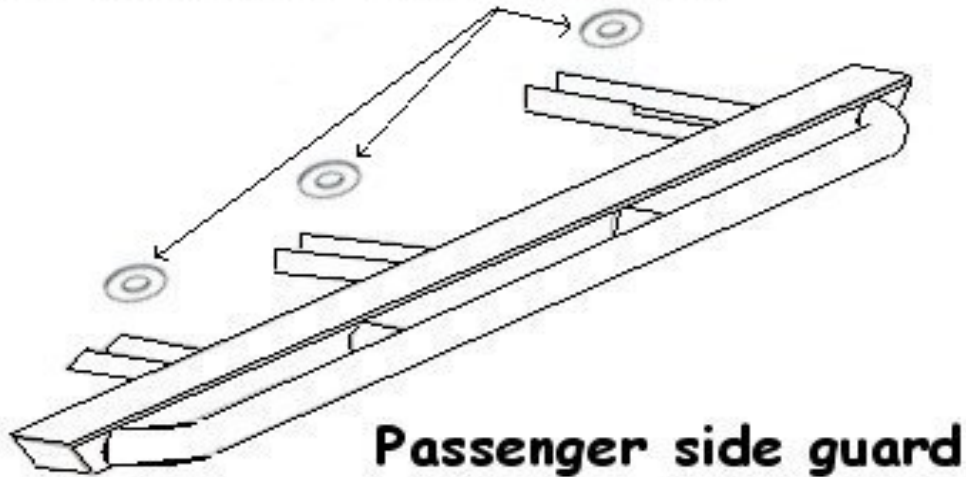
1/8" thick x 2" o.d. washers

There have been several cases of squeaking coming from the installation of our side guards on models with worn or over-compressed body mount bushings. This issue has been found mostly on TJ's, though there have been reports from at least one CJ and YJ owner. The issue has been identified as the top of the mounting channels slightly rubbing the underside of the body-mount outriggers during frame twist from entering and / or exiting uneven driveways, dips, etc. The only solution is to shim the mounting channels on the body-mount bushings to space the channels down and off the outriggers.

If you encounter squeaking after installing your side guards, a simple 1/8" thick x 2" o.d. washer between each channel and body-mount bushing will space the channels off the outriggers just enough to resolve and prevent this noise.
